# MERCERS POND DAM CT 00068

## PHASE I INSPECTION REPORT NATIONAL DAM INSPECTION PROGRAM

JULY 1980

Identification Number:	CT 00068
Name:	Mercers Pond Dam
Town:	Danbury
County and State:	Fairfield County, Connecticut
Stream:	Tributary to Kohanza Brook
Date of Inspection:	April 22, 1980

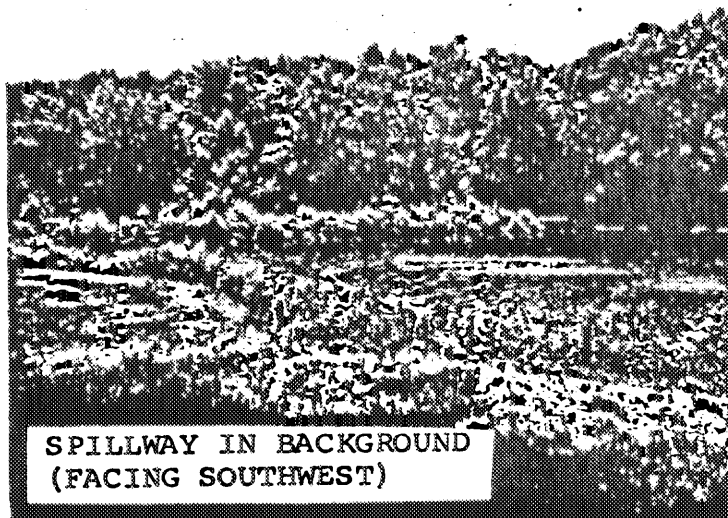
SPILLWAY IN BACKGROUND  
(FACING SOUTHWEST)

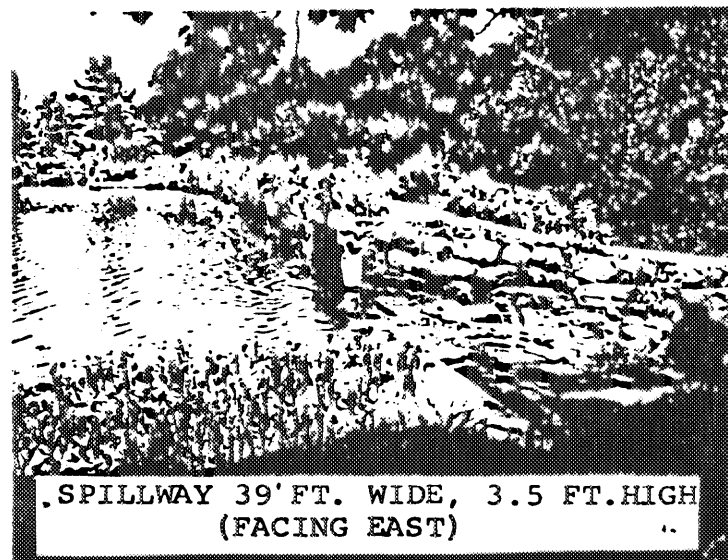
SPILLWAY 39' FT. WIDE, 3.5 FT. HIGH  
(FACING EAST)

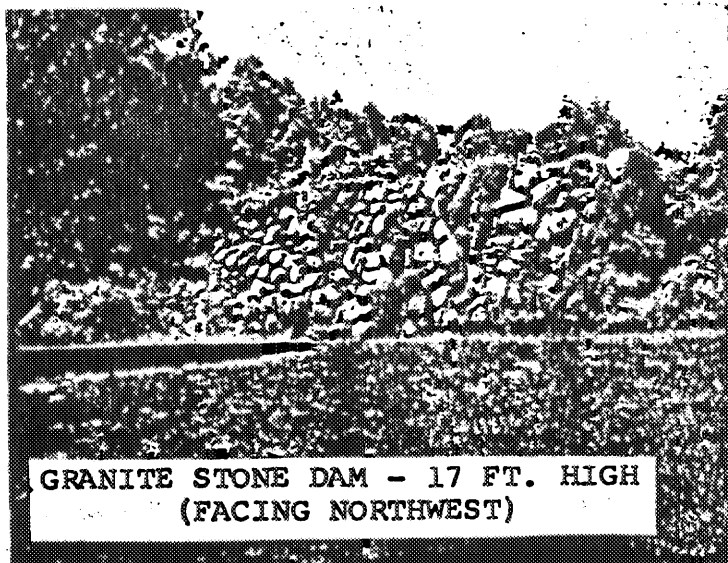
GRANITE STONE DAM - 17 FT. HIGH  
(FACING NORTHWEST)

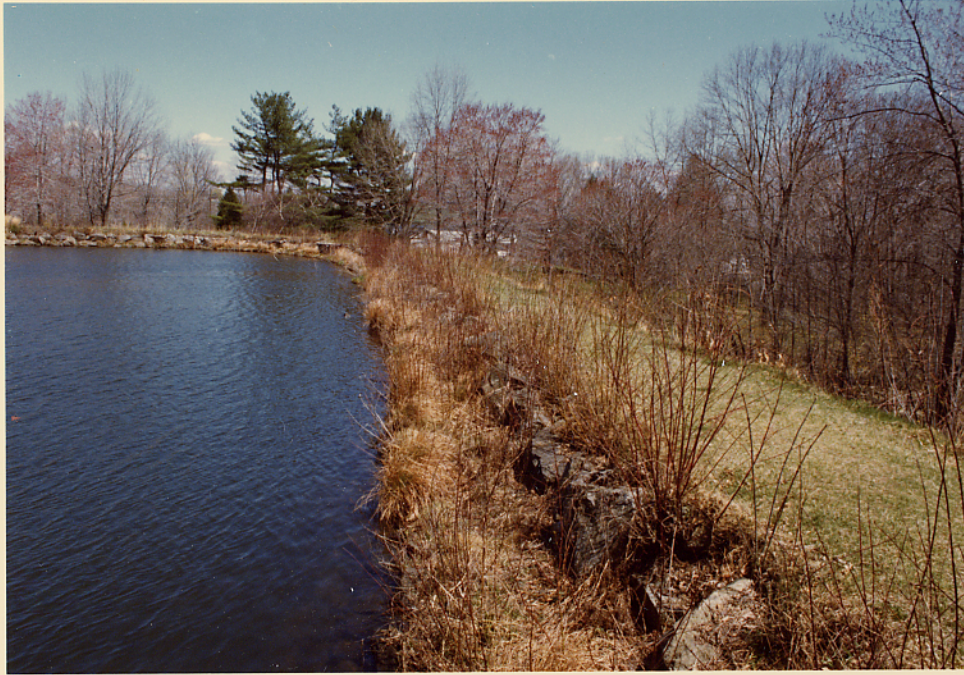
PHOTO 1  
CREST OF DAM

b. Dam - The dam is an earth embankment with portions of the downstream faced with granite blocks. The condition of this face varies. The eastern portion of the wall is in fairly good condition, the central portion of the wall seems to be bulging with the top stones missing and the western portion of the dam has completely fallen down (Photos 2, 5 and 7). The remainder of the downstream embankment is on a 2:1 slope with grass and some small trees growing on it. The top of the embankment is in good condition with grass and some brush growing on it. There are several low spots along the top of the dam, however, these low spots seem to have always been there and not a result of settlement. The upstream face of the dam is riprapped and is in good condition, but is overgrown with brush and weeds (Photo 1).

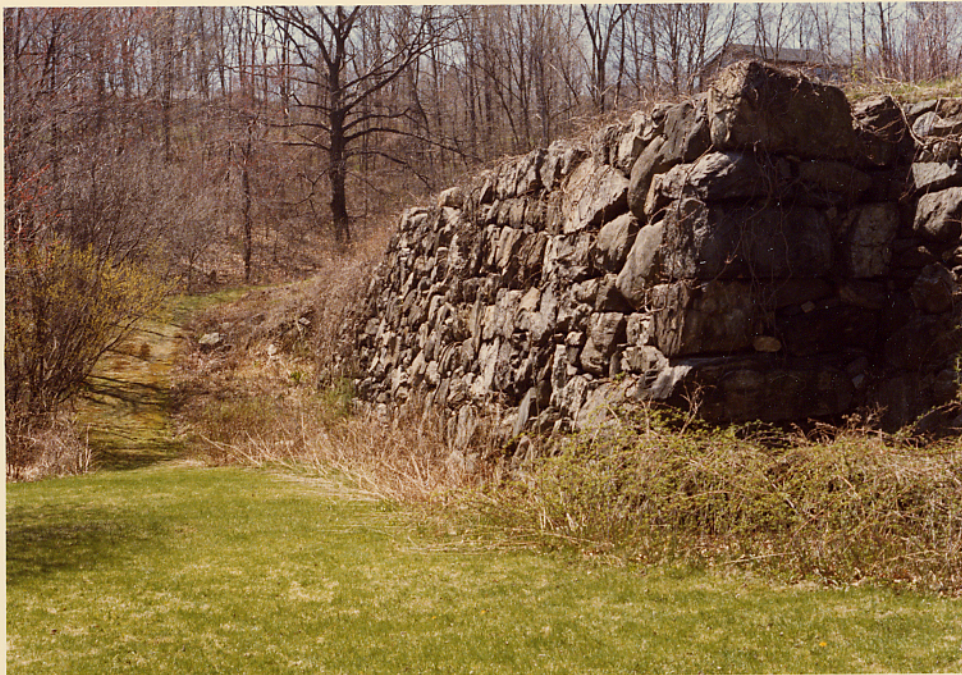
PHOTO 2  
DOWNSTREAM FACE OF DAM

The general structural stability of the dam is fair as evidenced by the vertical, horizontal and lateral alignment. The granite block face of the dam varies in condition from poor to good. The eastern half of the stone face is in good condition with good alignment. The central portion of the stone face has the uppermost stones removed and appears to have a bulge in the face. The western portion of the stone face has fallen down. It is not known when this happened or what caused it.

- a. Seepage through the dam and at the toe of the dam should be investigated further to determine its origin and monitored to determine any changes.
- b. Structural stability of the embankment and the granite block face should be analyzed, monitored and repaired.
- c. Prepare a detailed hydraulic/hydrologic study to determine spillway adequacy and an increase of the total project discharge if necessary.

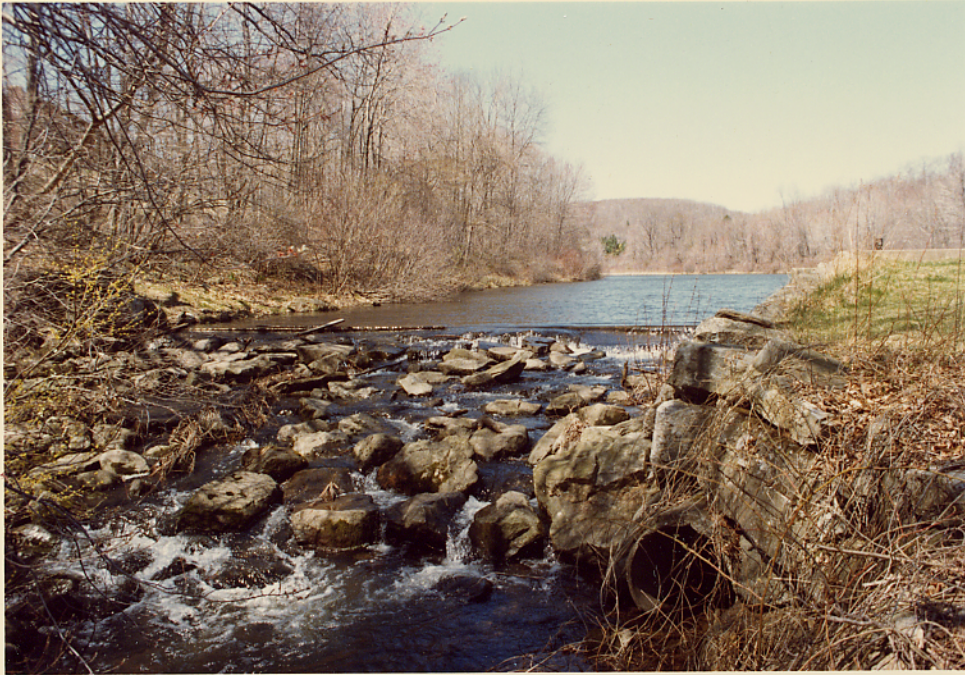
PHOTO 3  
SPILLWAY - UPSTREAM

The spillway is a fixed concrete weir that appears to be in good condition. The training walls for the spillway are dry rubble and are in fair condition, but could be a problem during high flow (Photo 3).

The spillway weir seems to be in good condition, but the training wall just below the spillway is in poor condition and could cause problems during high flow.

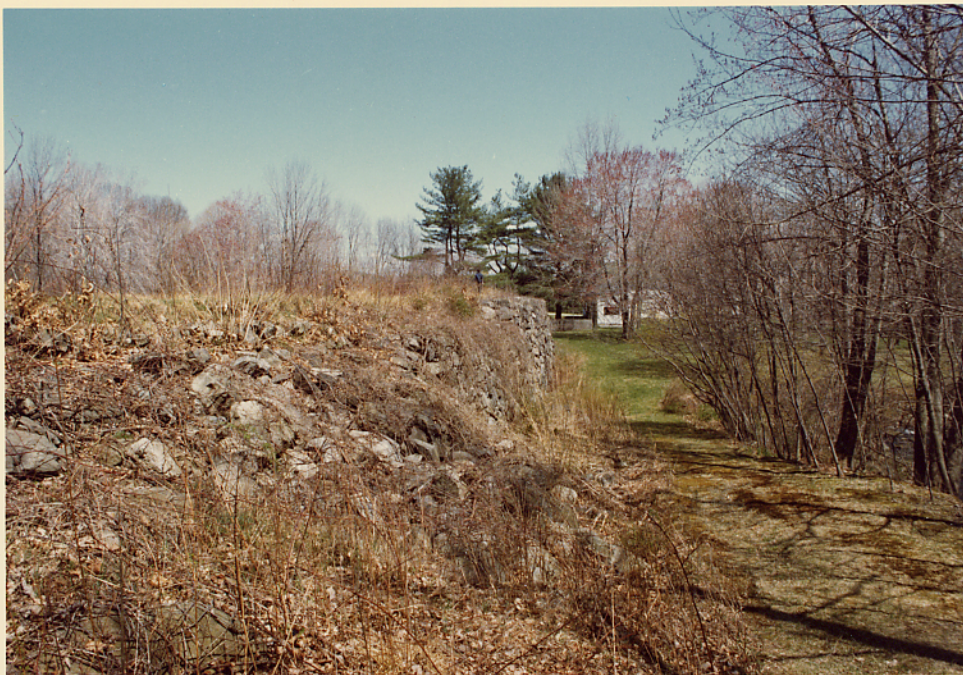
PHOTO 5

DETERIORATED DOWNSTREAM WALL - WEST SIDE

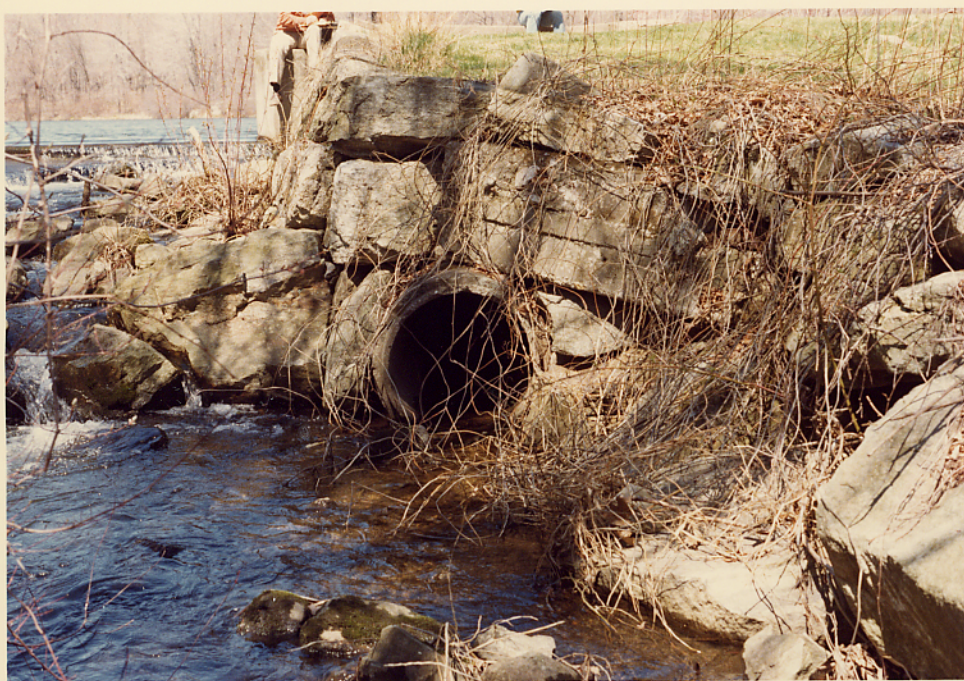
PHOTO 6

c. Appurtenant Structures - The concrete headwall for the slide gate is on the upstream side of the embankment and is in good condition, however, the slide gate is not operating and is closed. The 24-inch concrete pipe is in good condition (Photo 6).

OUTLET

(3) Slide gate should be repaired.

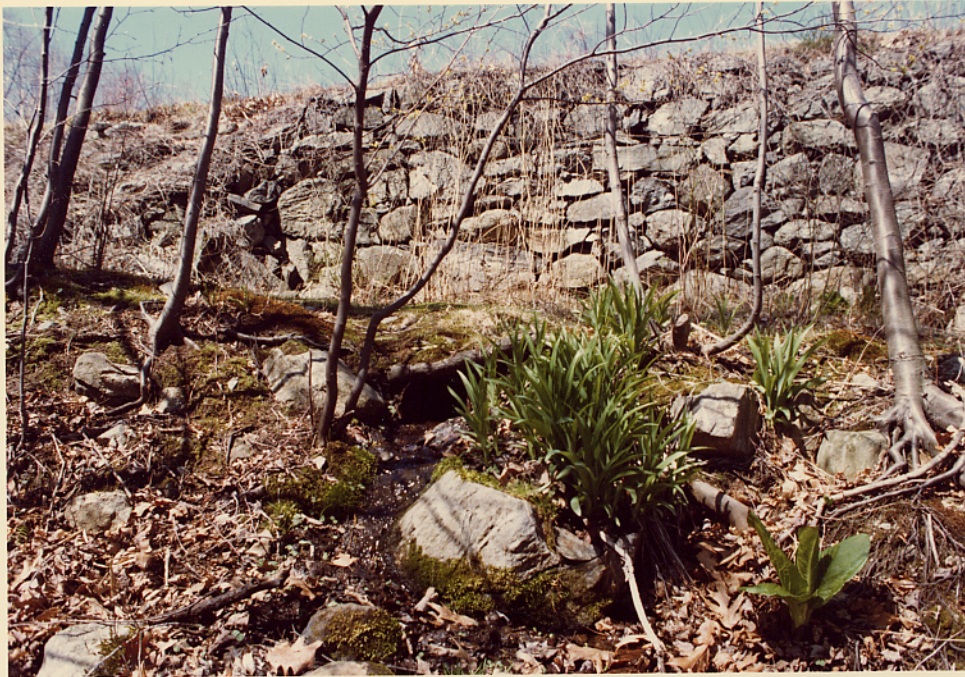
PHOTO 7  
SEEPAGE NEAR TOE OF DAM

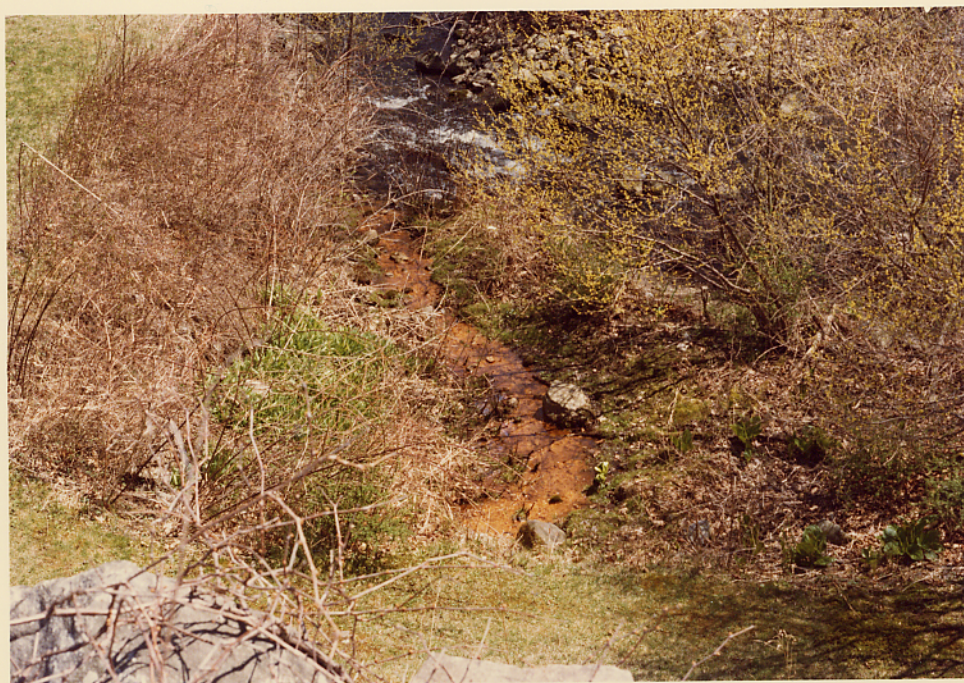
PHOTO 8  
SEEPAGE NEAR TOE OF DAM
